ST. FRANCIS RIVER BASIN  
NORTON, VERMONT

NORTON POND DAM  
VT 00198

PHASE I INSPECTION REPORT  
NATIONAL DAM INSPECTION PROGRAM

JANUARY 1979

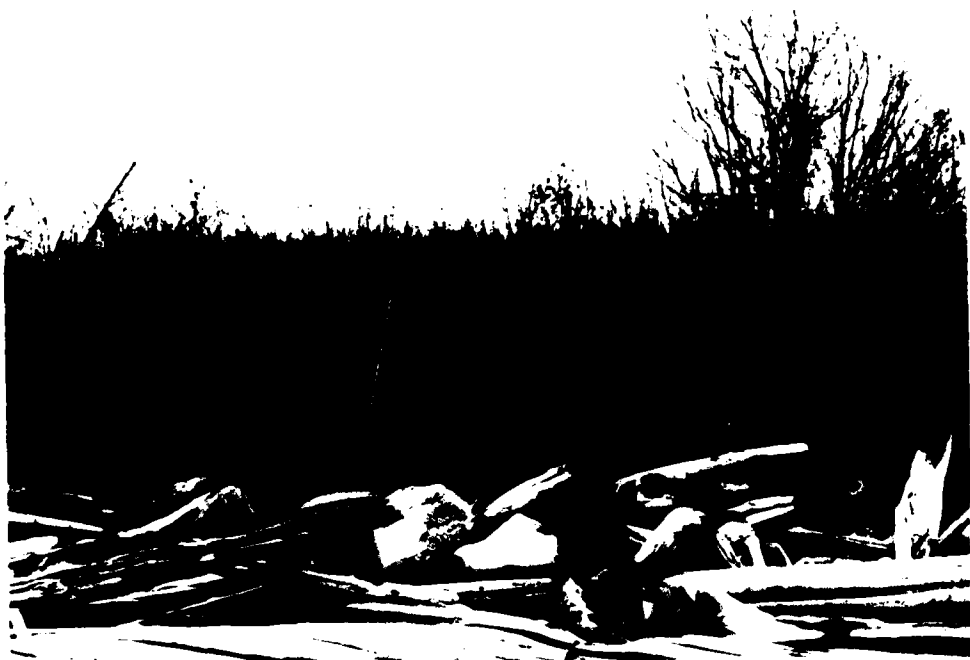
PHOTO NO. 15 - Slope failure at Station 7+64.

(a) The sloughing on the upstream face of the dam should be repaired.

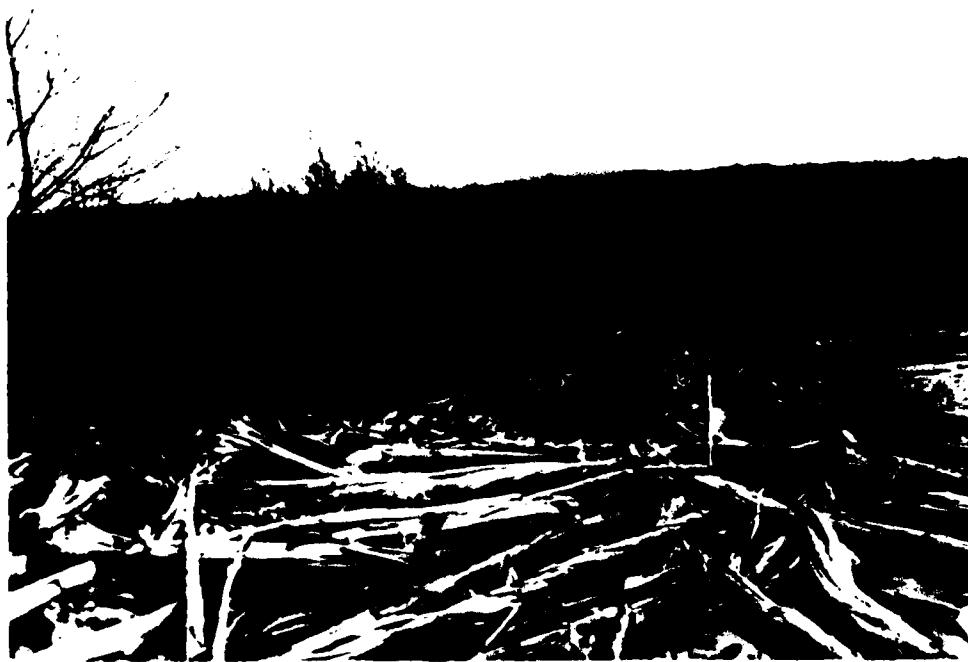
PHOTO NO. 16 - Upstream slope view from  
Station 7+50± towards right abutment.

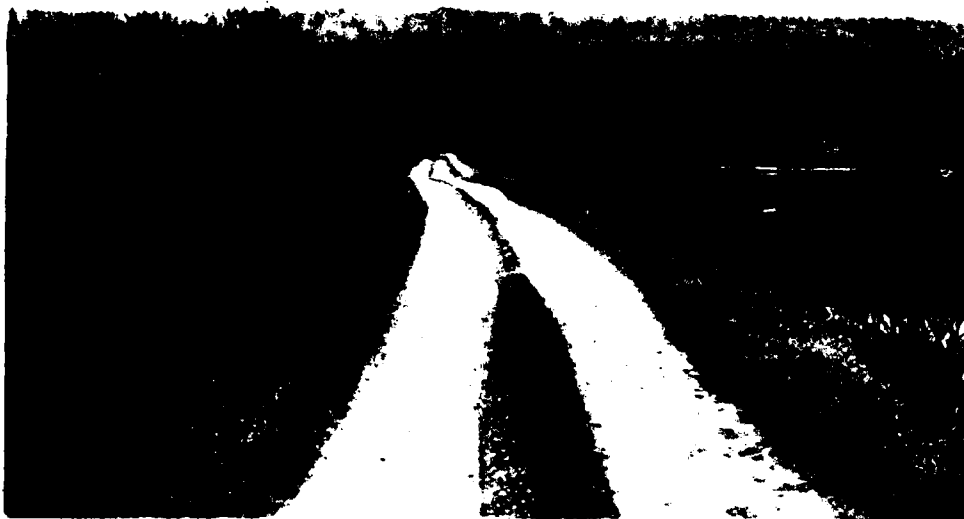
The crest width varies between 8 and 12 feet and is unpaved. A typical section of the crest is shown in Photo 13. No evidence of cracking or misalignment that could be attributed to embankment movement was observed.

PHOTO NO. 13 - Crest of dam from about Station 3+50 looking towards the right abutment.

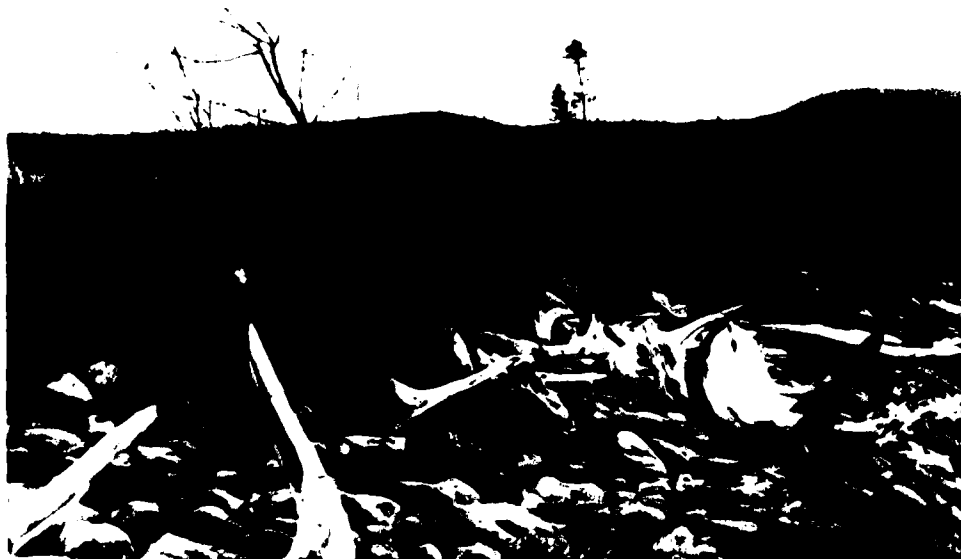
PHOTO NO. 12 - Slope failure at Station 2+23 viewed from crest of dam. The failure has extended to within 6 feet of the dam centerline and is about 50 feet long.
